Manhole Inspection Summary

Manhole # S06EE2001MH

Insp Date: **10/11/06 10:31 AM**

Location Address: **7000 PARK HEIGHTS AVE**

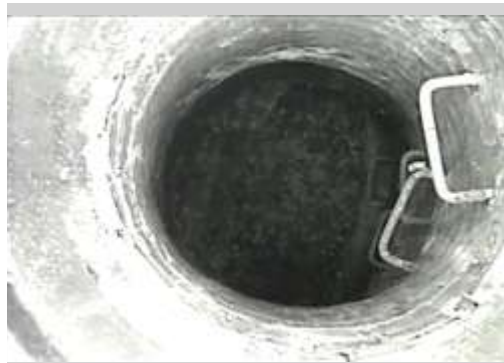
Top View

Infiltration: ☐ None ☒ **Joint** ☐ Cracks ☐ Mortar ☐ Roots ☒ **Wall**

☒ **Debris** (not Condition related)

Adjustment infiltration. Channel debris.

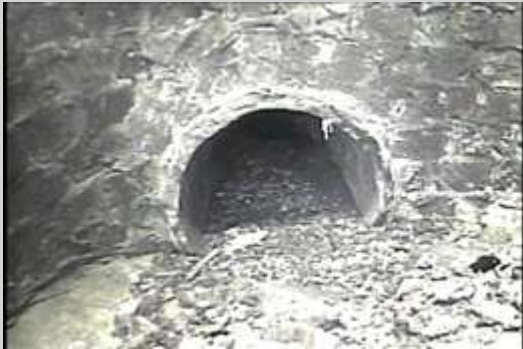
12 in. Circular Gravity Sewer
Pipe Out @ 12 O'Clock

Deposits: ☐ None ☒ **Mud** ☐ Sludge ☒ **Debris** ☐ Grease

Silt Depth: **2** (in.) Deposits Extent: **Light**
